# Manhole Inspection Summary

Manhole # S29EE1003MH

Insp Date: **4/2/07 11:05 AM**

**Location** Address: **501 TUDOR ARMS**

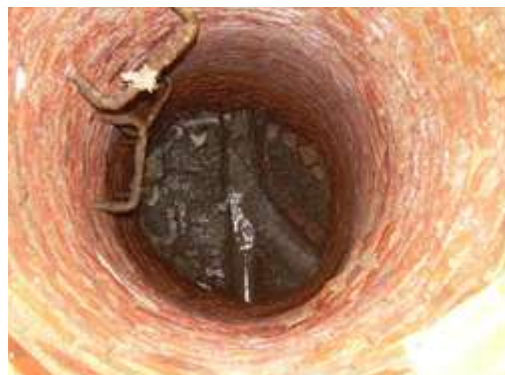
Top View

Corroded steps. Bench and Channel debris.

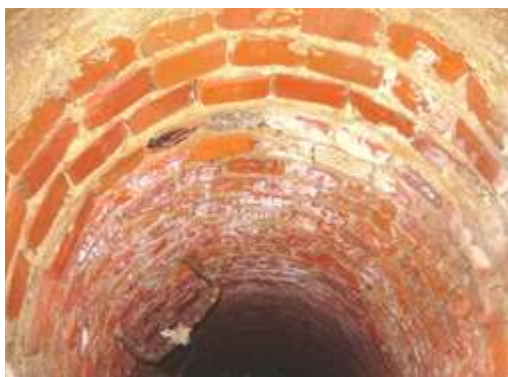
Defect

Adjustment and Corbel infiltration.

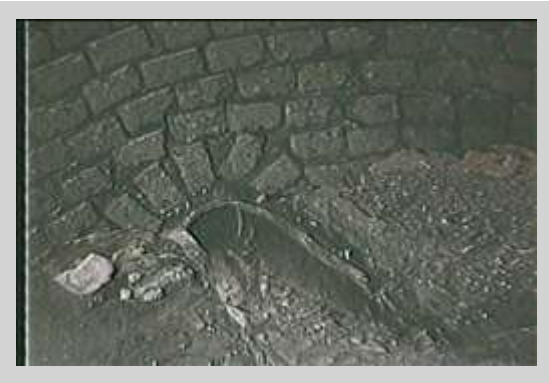
### 8 in. Circular Gravity Sewer Pipe Out @ 12 O'Clock

Barrel deterioration and infiltration.

Infiltration: **Evidence** Pipe Seal Cond: **Unknown**

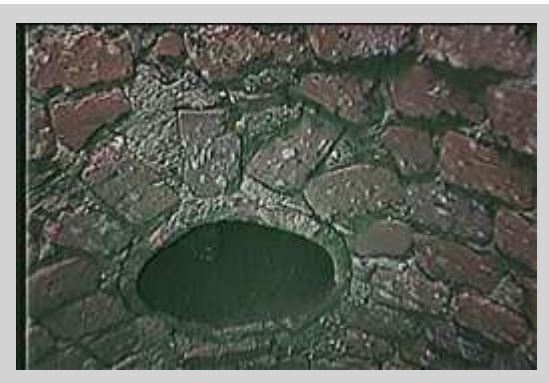
### 8 in. Circular Gravity Sewer Pipe In @ 4 O'Clock

Infiltration: **Evidence** Pipe Seal Cond: **Unknown**

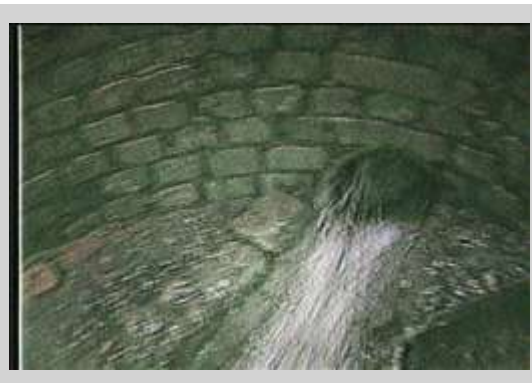
### Drop In @ 4 O'Clock

Barrel deterioration and infiltration.
